## **California State Board of Equalization Building Assessment**

450 N Street  
Sacramento, California

### **Final Report**

*Project No. 2372-572*

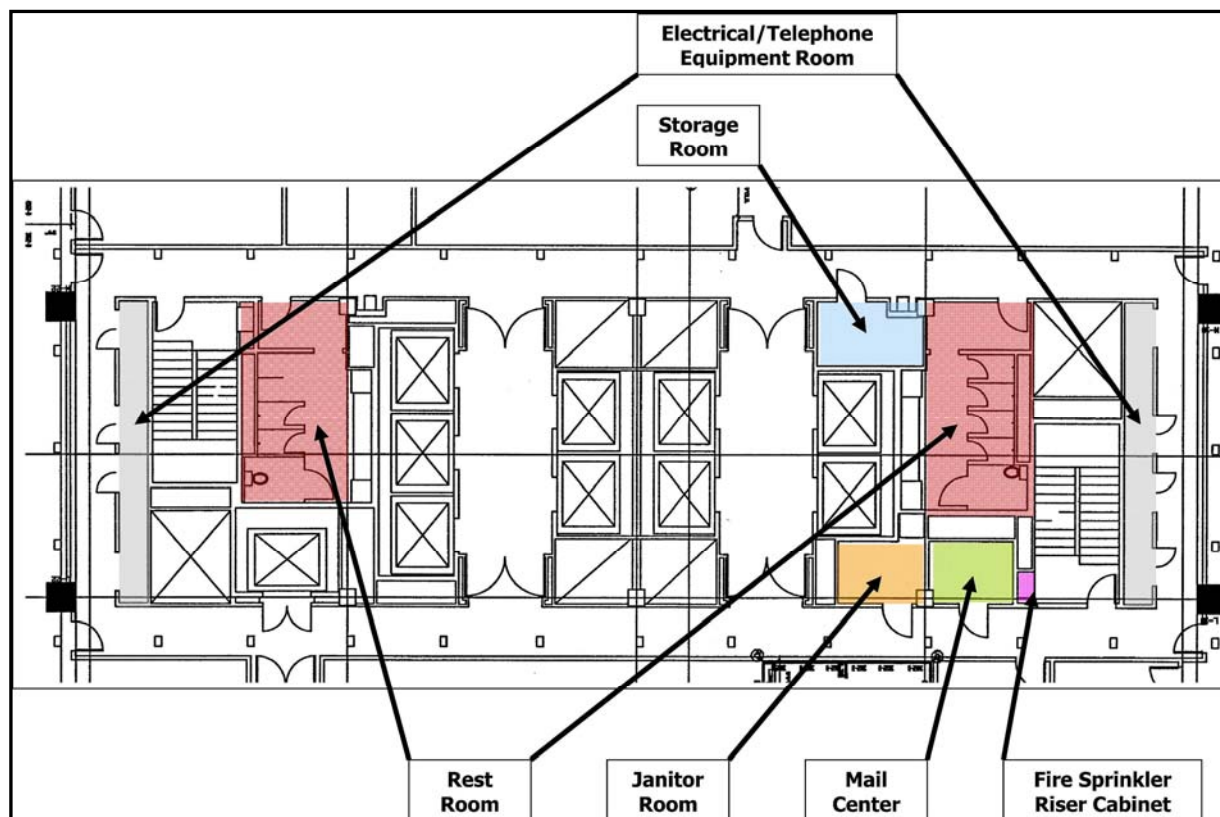
Figure 4.1 Typical Location of Building Core Rooms Located below Floor M (12<sup>th</sup> Floor)

On September 26, 2008, the FSR cabinet (located in the southwest stairwell) and the janitor room (located at the east end of the south hallway) on each floor were surveyed. On September 30, 2008, the storage rooms, mail center, and electrical/telephone equipment rooms were also surveyed. The restrooms (above the hard ceiling only) were surveyed by Mr. Ice on November 6 and 25, 2008. Except for the restrooms, areas above and below the ceiling were surveyed wherever a hard ceiling with an access hatch was present. No air, bulk, or surface tape lift samples for mold were collected during this component of the core investigation.

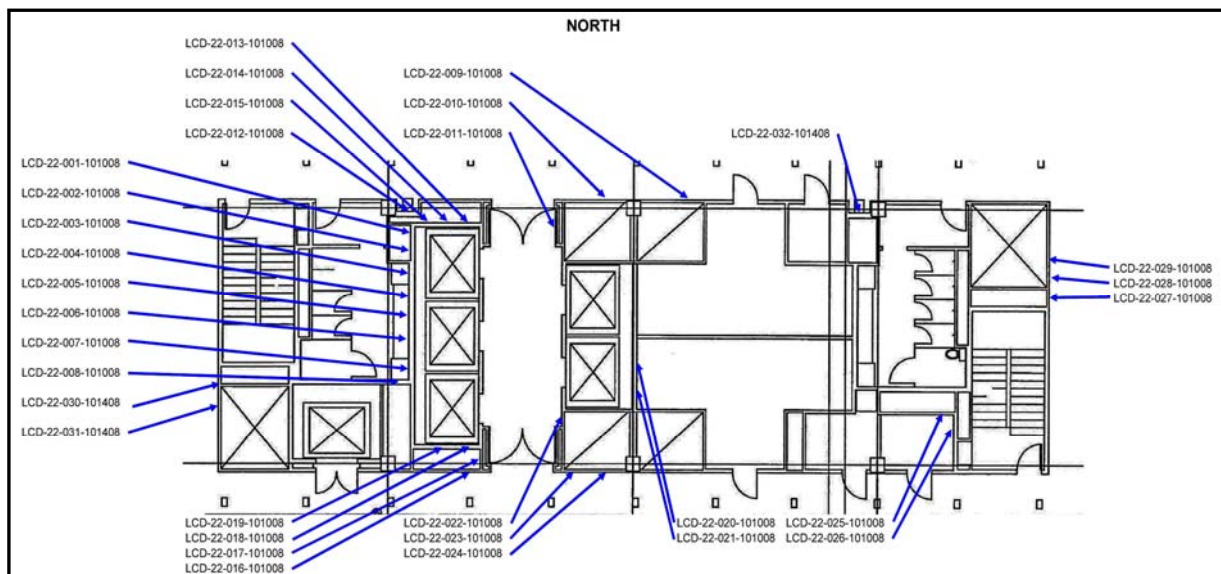
Figure 4.2 Typical Destructive Testing Locations

The destructive testing included physically cutting through selected walls and ceiling components of the building, visually observing, photographically recording, and collecting bulk and surface tape lift samples. Information from the interviews, historical document review, elevator shaft investigation and building core visual survey was compiled, evaluated, and used in the selection of the destructive testing locations. Typical destructive testing locations are depicted below in Figure 4.2.

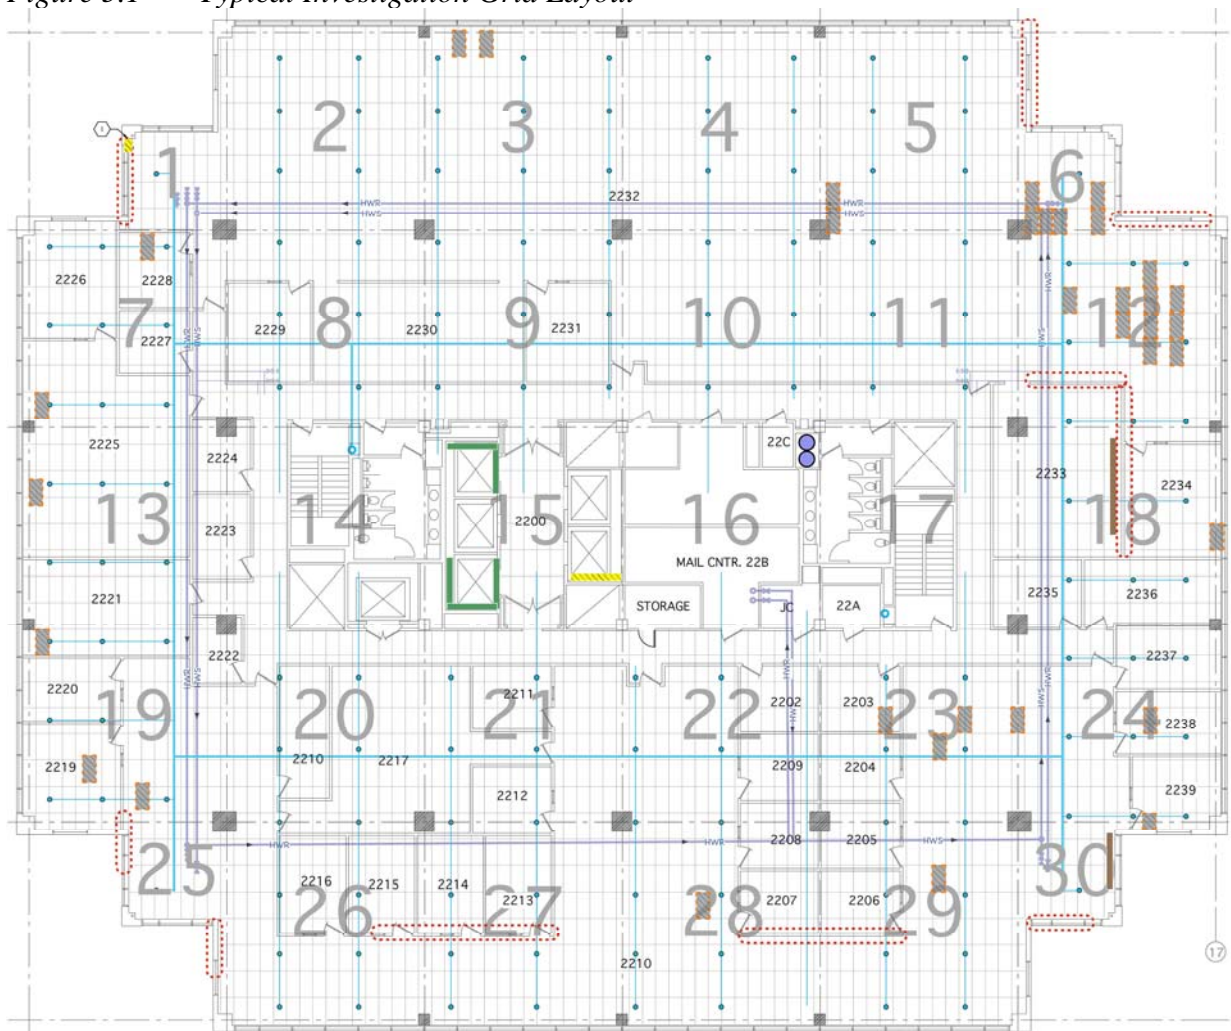
Figure 5.1 Typical Investigation Grid Layout

Using the floor drawings with the historical water damage data and the existing column lines of the building, LCD overlaid each of the floor drawings with a matrix of thirty (30) investigation grids. Floors 1 and 2 have different floor plans and, therefore, additional grids were added to accommodate their unique floor plans.
